PRESERVATION PLAN AND RECOMMENDATIONS FOR THE COTTAGE CEMETERY, AUGUSTA, GEORGIA

Prepared By:
Michael Trinkley, Ph.D.
and
Debi Hacker

CHICORA RESEARCH CONTRIBUTION 493

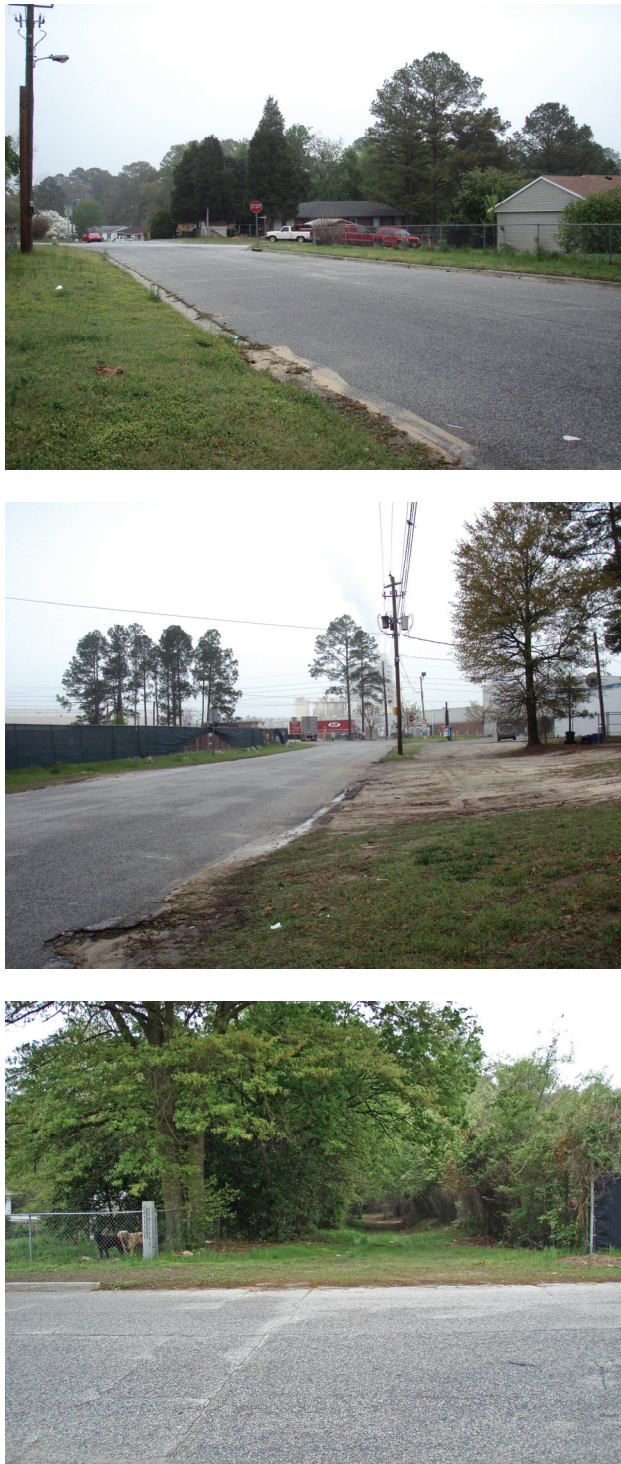
Figure 3. Area surrounding the cemetery. Top, Apple Valley neighborhood; Middle, view along Winesap Way toward the Protor & Gamble plant; Bottom, entrance to the cemetery off Winesap.

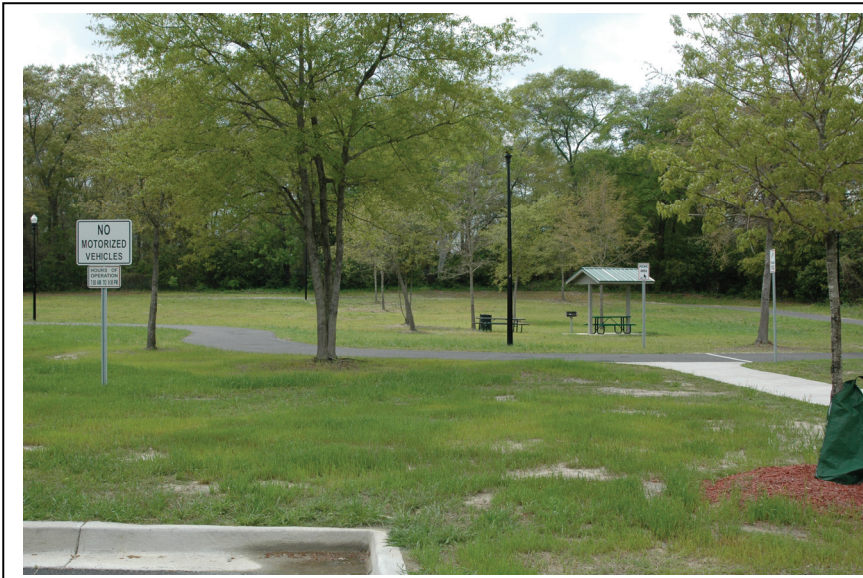
Figure 4. View of Apple Valley Park looking west, Cottage Cemetery in the background.

industrial site, a park, and a major highway. However, the park has a relatively green setting and the planners located a low-impact grassed area adjacent to the cemetery (see Figure 4). The cemetery property itself also offers some buffer from the highway to the south and the nearby industrial settings. This buffer is a critical feature in lowering the visual and noise impacts on the cemetery.

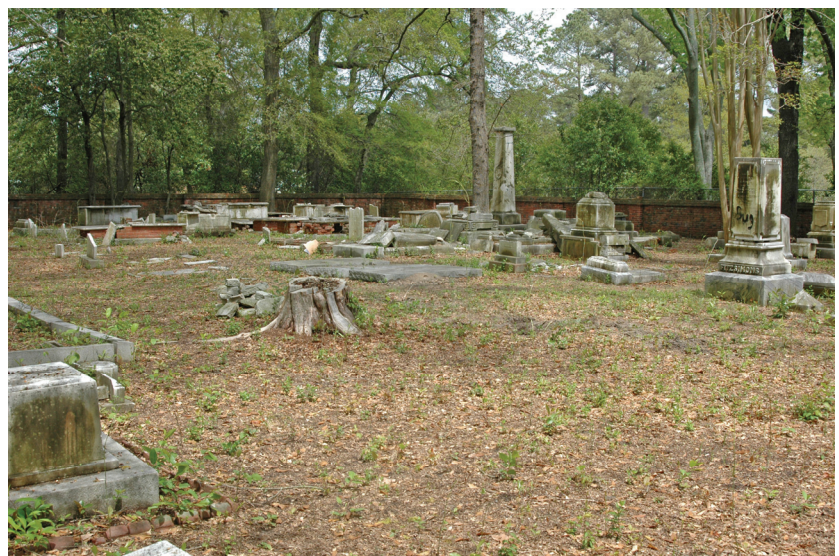
Figure 5. Interior of the cemetery showing its deteriorated condition. View to the east.

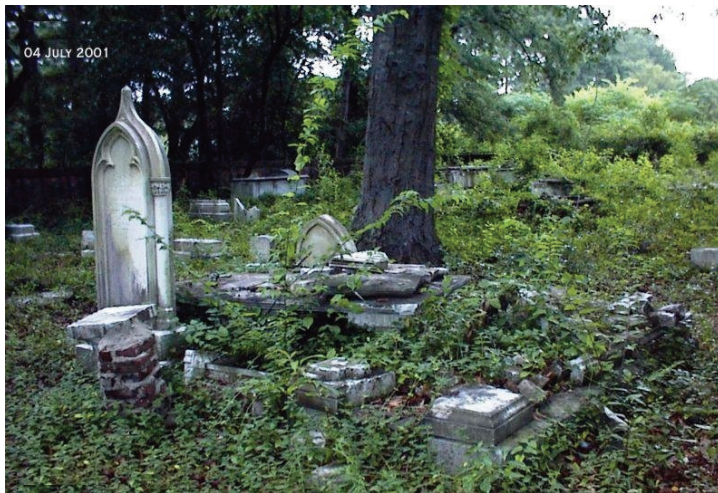
Figure 6. View of the cemetery in 2001 prior to being cleaned by the Augusta Chapter of VMI Alumni.

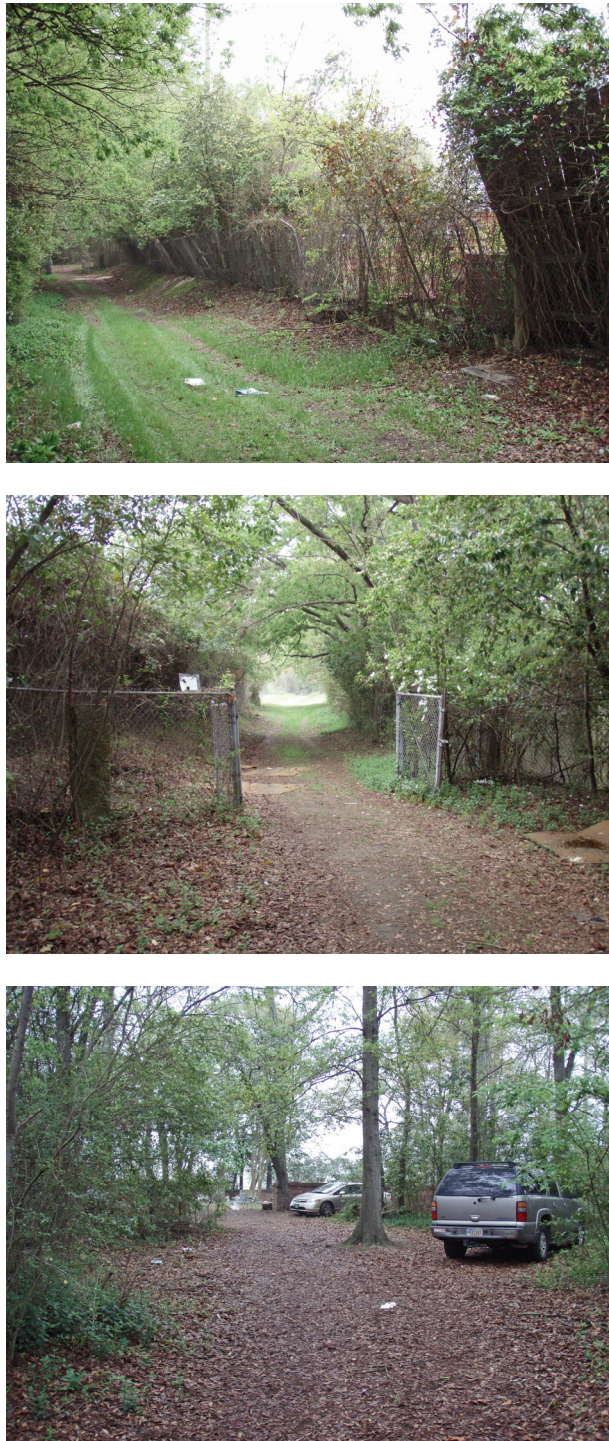
Figure 9. Access road and conditions. Top, condition of road, vegetation, and fence to south of the road; Middle, entrance looking out toward Winesap Way; Bottom, parking at entrance to the cemetery.

Once on the cemetery property we recommend that the road be straightened and the corridor be increased to match the 18 feet cleared on the public right-of-way. This would provide a clear view of the cemetery upon entering – and a clear view of the exit upon leaving.

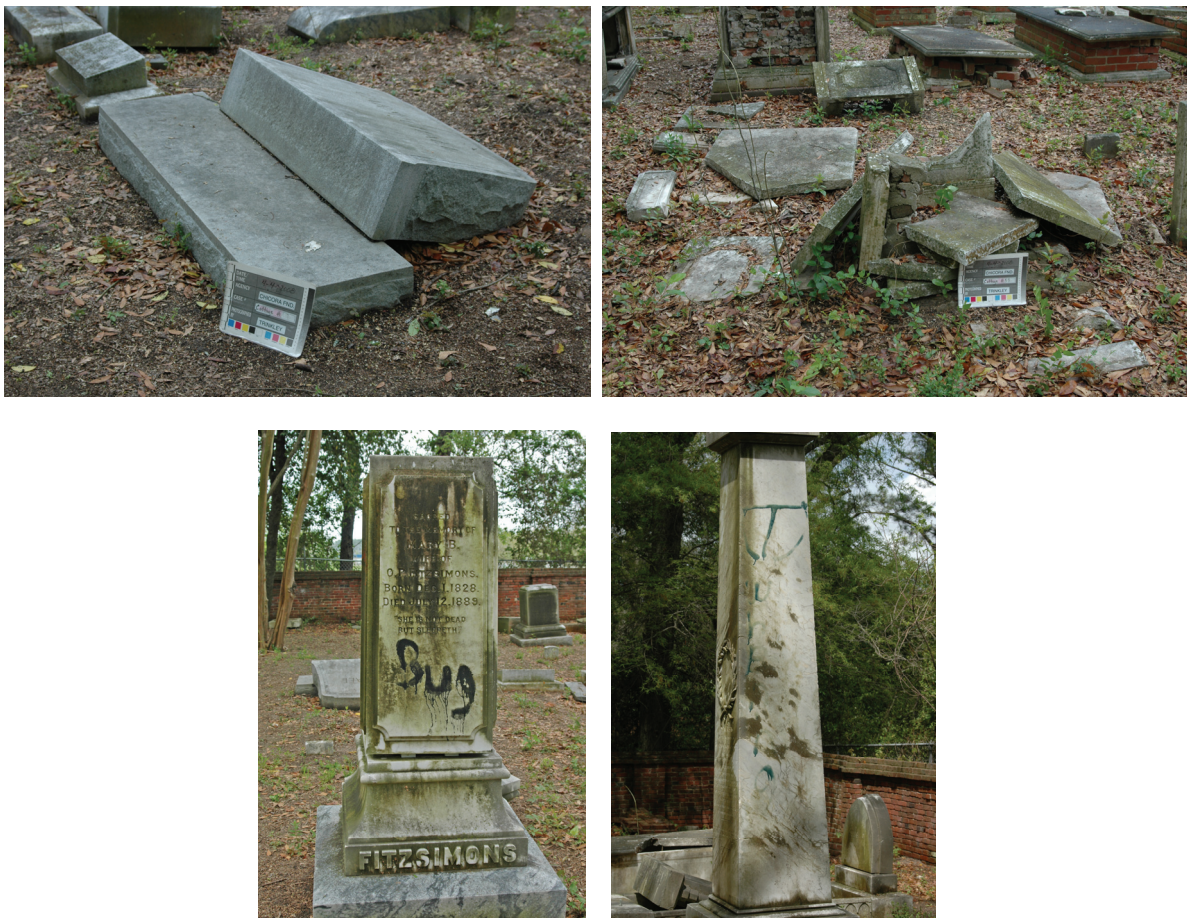
Figure 11. Examples of vandalism in the cemetery include toppling of monuments, breaking of monuments, and spray painted graffiti.

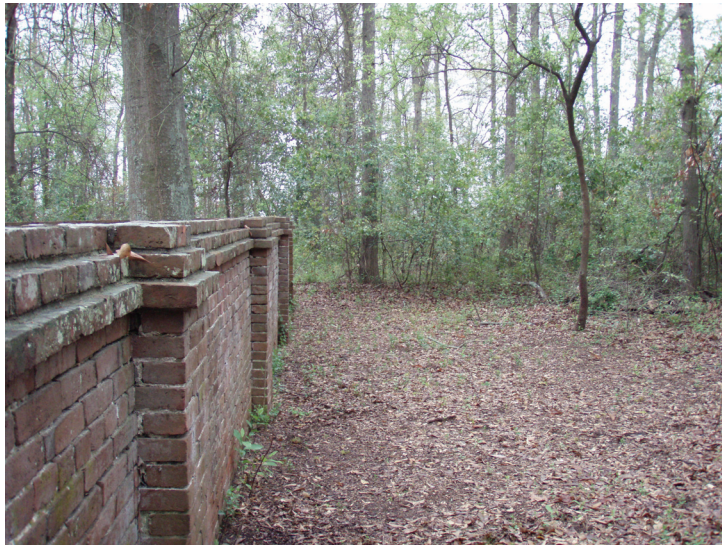
Figure 12. Example of thick vegetation beyond the cemetery.

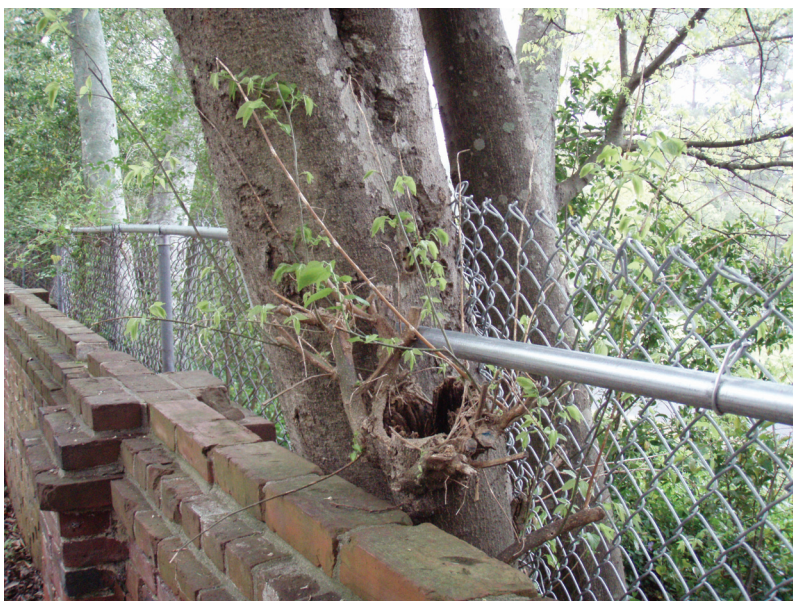
At the present time the fence is in poor condition. The top rail has been damaged by a large tree. The three-wire 45° barbarns which were once on the fence have been removed, probably through a combination of poor maintenance and vandalism.

Figure 13. Dilapidated chain link fence between the cemetery and park, showing loss of the barbwire and damage from the tree.

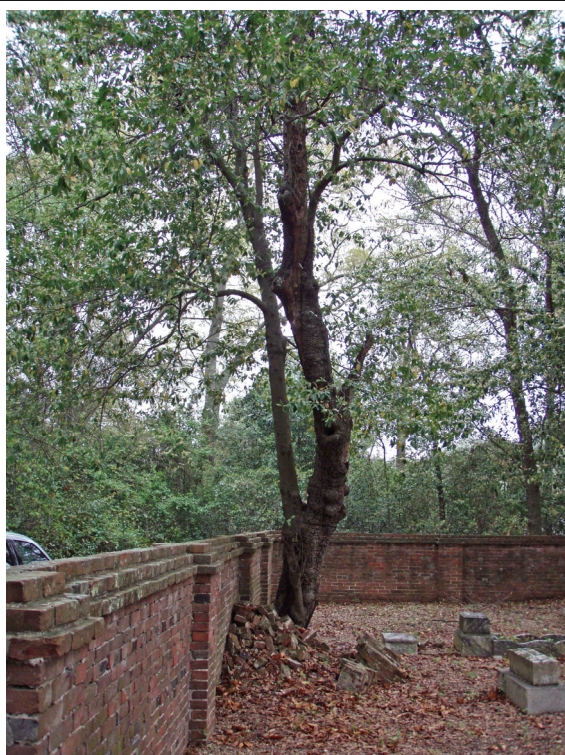
Figure 16. Example of a cherry laurel that should be removed from the cemetery.

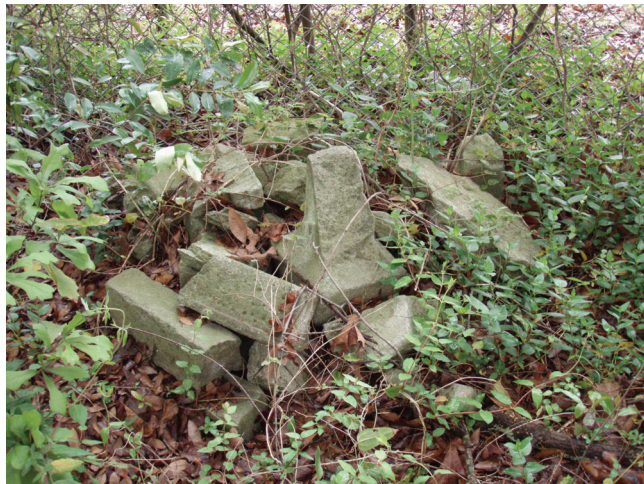
Figure 17. Fragments of stones found piled in the woods beyond the brick wall. These should be carefully collected and stored.

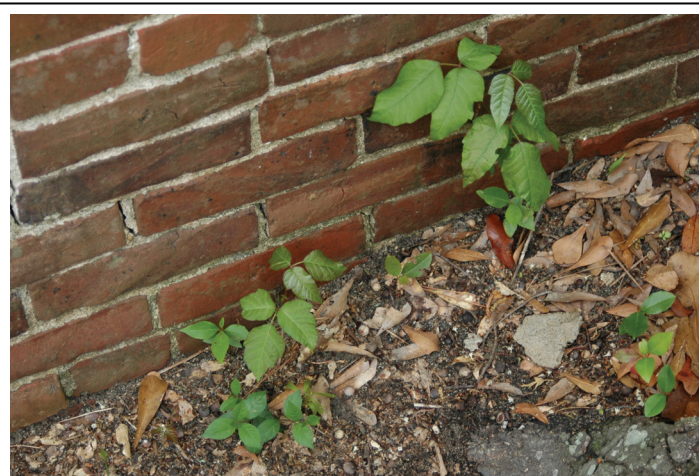
Figure 18. Poison ivy growing along the cemetery wall.

Chemical control is limited to non-selective post-emergence herbicides, with Roundup Pro® being the compound of choice since it translocates to roots of perennial vines.³ However, you may need to make repeated applications to completely kill a perennial vine with a deep, well-established root system. It is necessary to use a directed or shielded spray to avoid contact with the bark of desirable plants, as well as to avoid stones.

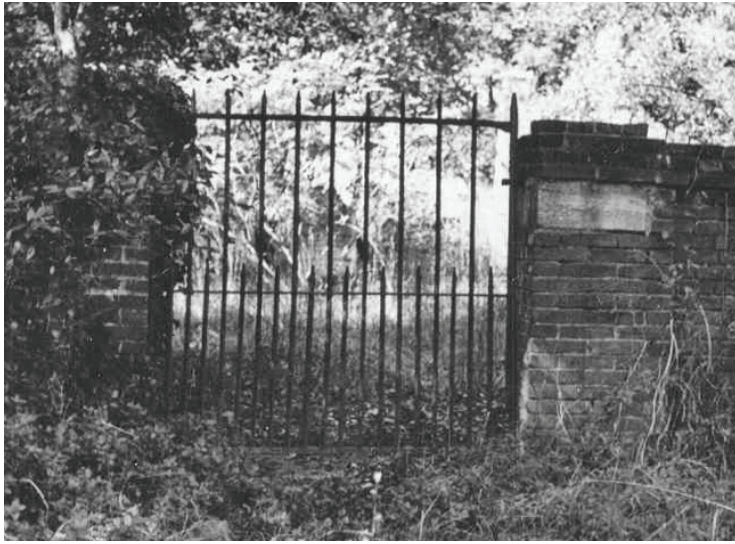
Figure 19. Photo showing the original gate and columns.

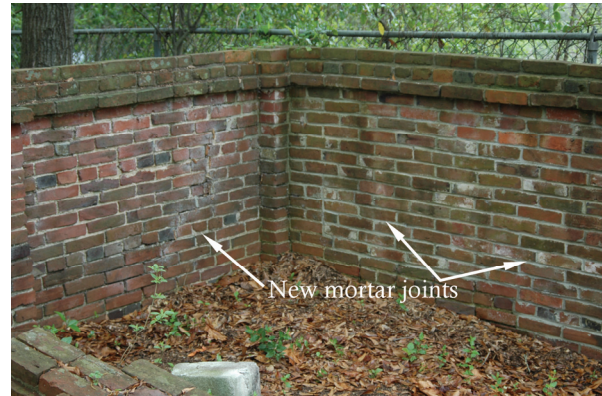
At least two additional areas of new brickwork are clearly visible – one along the center of the east wall and a second at the northeast corner. In both cases the bonding pattern has been lost and the brick has been laid using a hard Portland

Figure 20. Two areas of wall repair. Note the light colored (new) mortar and the loss of the original bonding pattern. Note also on the left photo areas of brickwork requiring repointing, as well as sections of old wall lying on the ground.

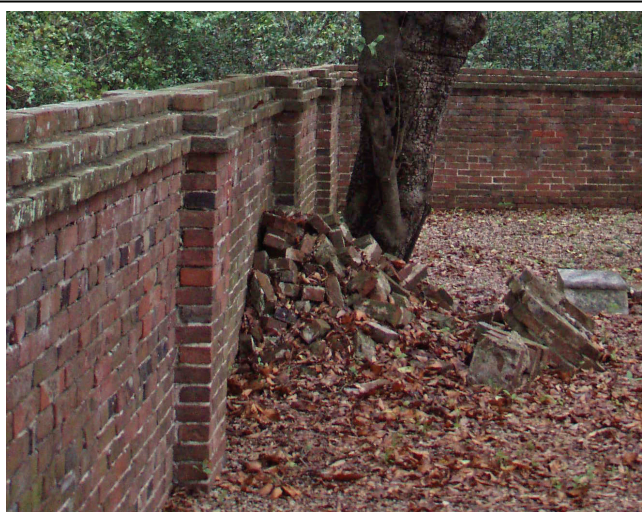
Figure 21. Brick pile along the west cemetery wall.

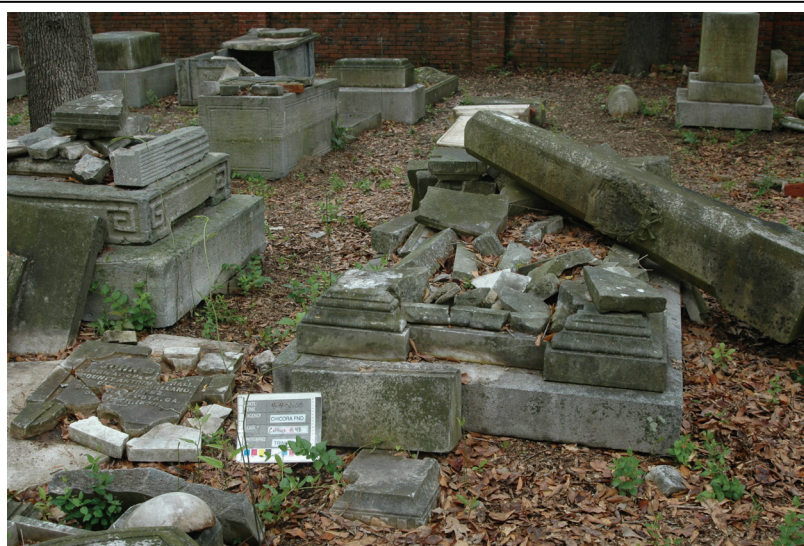
Figure 22. Example of badly damaged and heavily fragmented monument.

The caregivers should realistically evaluate their fund raising abilities and determine how long it will be before conservation efforts may begin. If the repair of monuments is more than a year away, it may be appropriate to collect these smaller fragments,

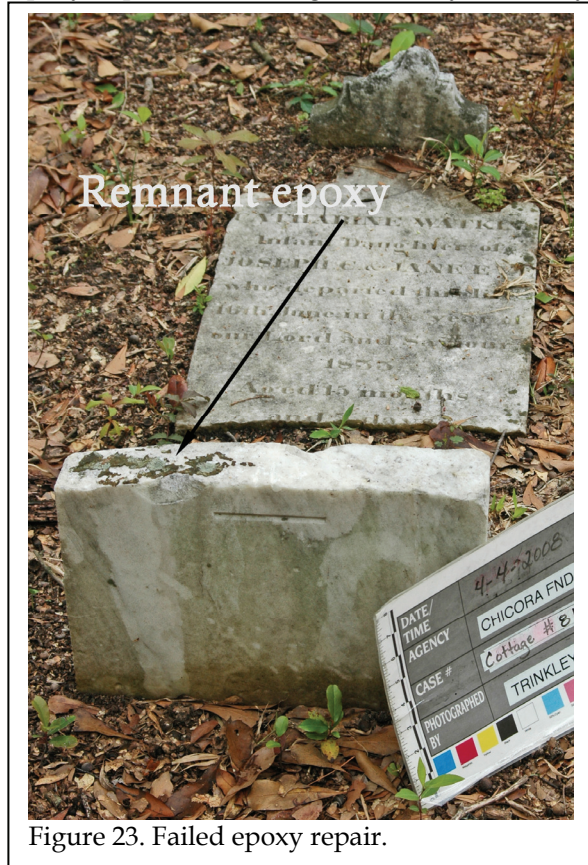
We see many examples of “simple epoxy repairs” at Cottage Cemetery. Virtually

Figure 23. Failed epoxy repair.

After many such repairs it will be necessary to fill the voids with a natural cementitious composite stone material resembling the original as closely as possible in texture, color, porosity, and strength. This type of repair may be used to fill gaps or losses in marble and is often used to help slow scaling of bedded sandstone exposed to the elements.

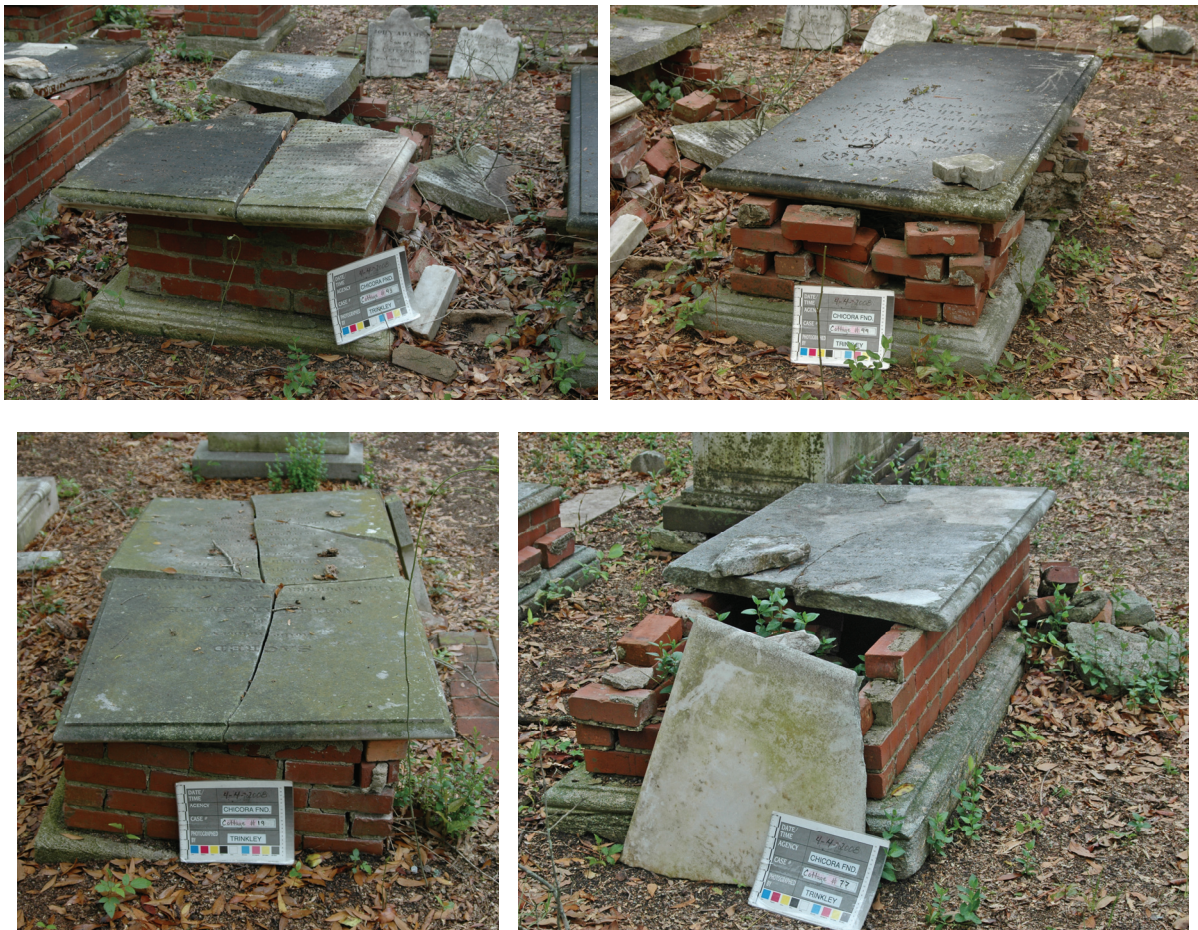
With that said, it is important to realize that many of the monuments in the Cottage Cemetery have been heavily damaged. For several, the damage is very extensive and the fragments – at least those observed during this assessment – are very small. It is our opinion that for several markers repair *is not feasible* – either in terms of the current technology or in terms of the costs associated. For these we

Figure 25. Examples of collapsing brick box tombs that require repair.

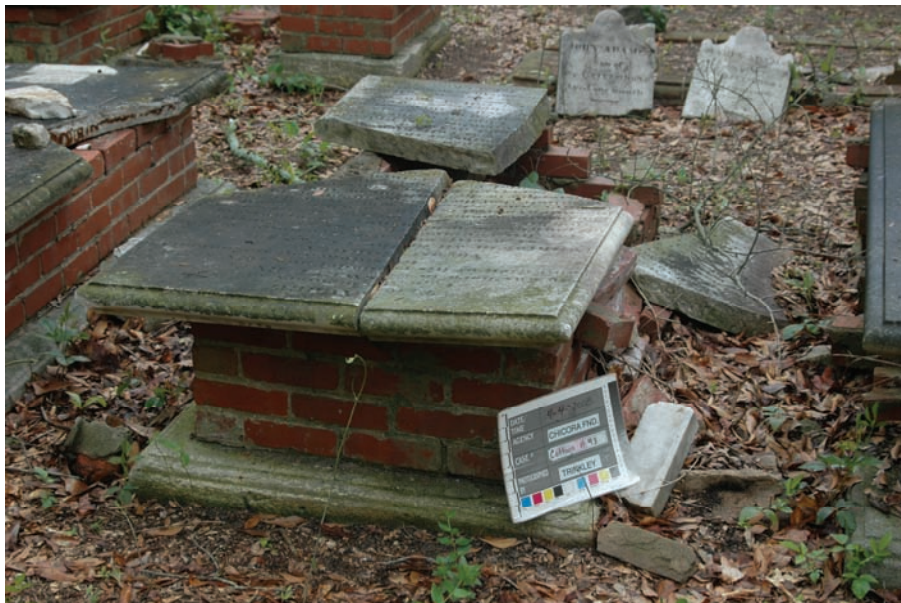
Cottage Cemetery, Augusta, GA Monument Treatment Proposal

Position: ☐ fallen ☐ tilted ☒ unstable ☒ unattached/loose ☐ missing

Deterioration: ☐ broken ☐ cracked ☐ losses ☐ flaking/sugaring ☐ ferrous pins ☐ brass pins
☐ delamination/detachment ☐ spalling ☐ missing fragments ☒ other: box deteriorating and putting
ledger, currently intact, at risk.

Soiling: ☒ biological ☐ staining ☐ efflorescence ☐ other:

Position: ☐ reset/level in ground ☐ reset/level to existing base ☐ construct new base ☐ resquare
☐ possible new base required ☒ stabilize foundation ☒ reset with 0:1:3 mix ☐ reset with compound

Treatment: ☐ core drill ☐ drill and pin ☐ simple adhesive repair ☐ injection grout ☒ replace bricks
☐ mortar ☐ repoint ☐ infill ☐ other:

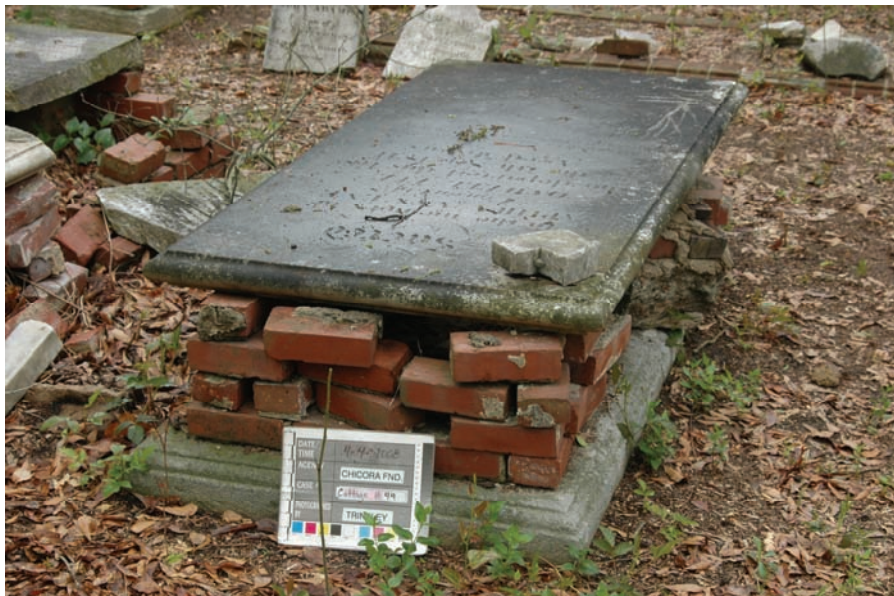
Cottage Cemetery, Augusta, GA Monument Treatment Proposal

Position: ☐ fallen ☐ tilted ☐ unstable ☐ unattached/loose ☐ missing

Deterioration: ☒ broken ☐ cracked ☐ losses ☐ flaking/sugaring ☐ ferrous pins ☐ brass pins
☐ delamination/detachment ☐ spalling ☐ missing fragments ☐ other:

Soiling: ☒ biological ☐ staining ☐ efflorescence ☐ other:

Treatment: ☐ core drill ☐ drill and pin ☒ simple adhesive repair ☐ injection grout ☐ replace bricks
☐ mortar ☐ repoint ☒ infill ☐ other:

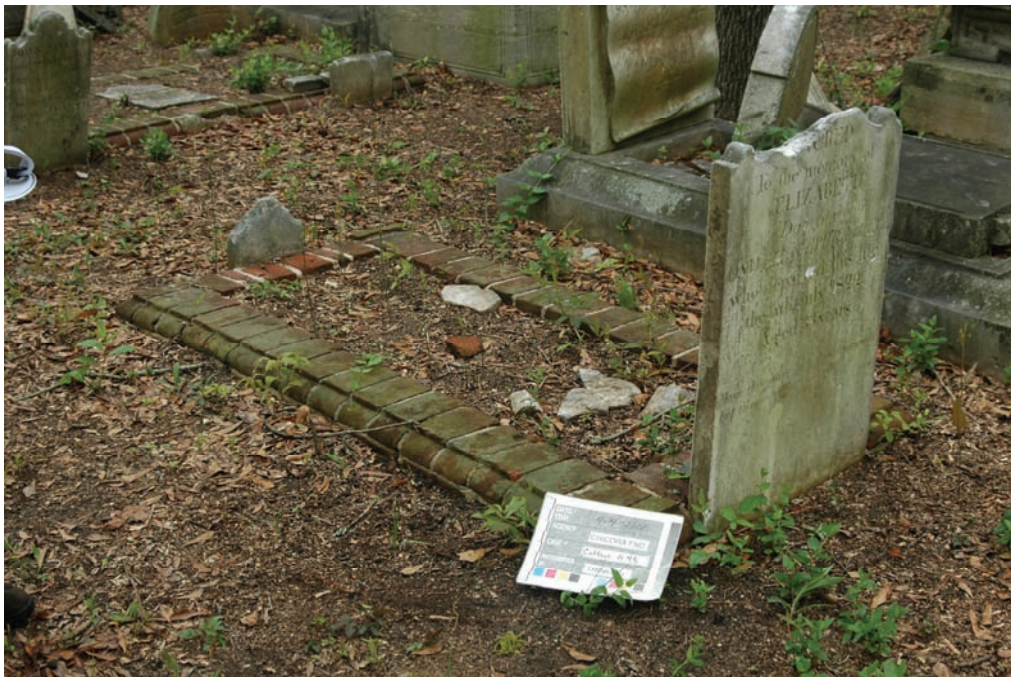
Cottage Cemetery, Augusta, GA Monument Treatment Proposal

Position: ☒ fallen ☐ tilted ☐ unstable ☐ unattached/loose ☐ missing

Deterioration: ☒ broken ☐ cracked ☐ losses ☐ flaking/sugaring ☐ ferrous pins ☐ brass pins
☐ delamination/detachment ☐ spalling ☐ missing fragments ☐ other:

Soiling: ☒ biological ☐ staining ☐ efflorescence ☐ other:

Position: ☐ reset/level in ground ☒ reset/level to existing base ☐ construct new base ☐ resquare
☐ possible new base required ☐ stabilize foundation ☒ reset with 0:1:3 mix ☐ reset with compound

Treatment: ☐ core drill ☒ drill and pin ☐ simple adhesive repair ☐ injection grout ☐ replace bricks
☐ mortar ☐ repoint ☒ infill ☐ other:

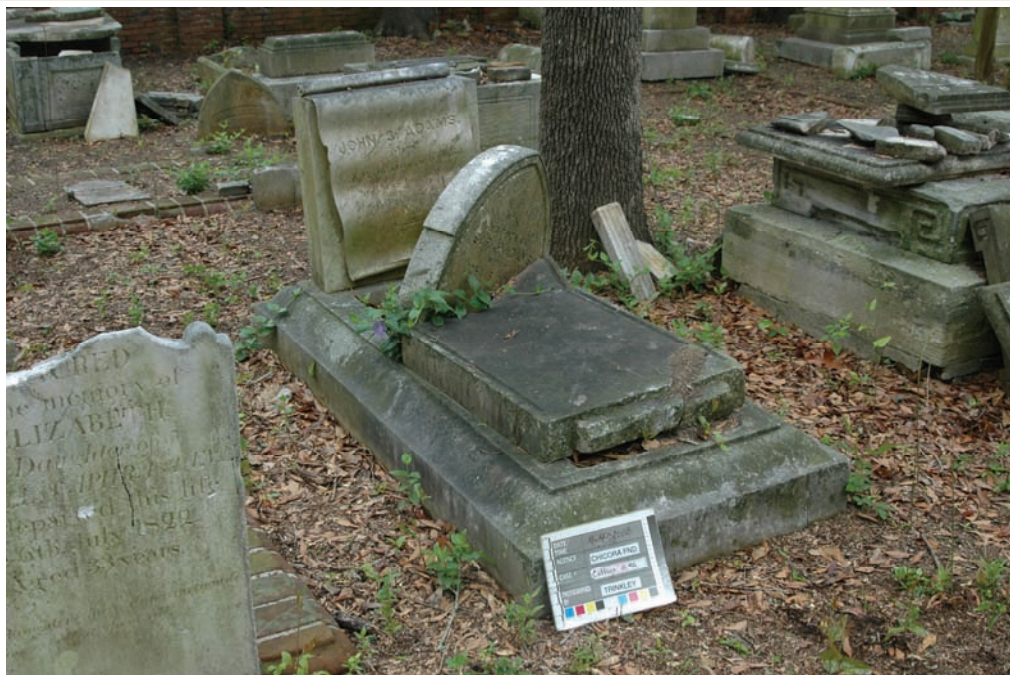
Cottage Cemetery, Augusta, GA Monument Treatment Proposal

Position: ☒ fallen ☐ tilted ☐ unstable ☐ unattached/loose ☐ missing

Deterioration: ☒ broken ☐ cracked ☐ losses ☐ flaking/sugaring ☐ ferrous pins ☐ brass pins
☐ delamination/detachment ☐ spalling ☒ missing fragments ☐ other:

Soiling: ☒ biological ☐ staining ☐ efflorescence ☐ other:

Treatment: ☐ core drill ☐ drill and pin ☐ simple adhesive repair ☐ injection grout ☐ replace bricks
☐ mortar ☐ repoint ☐ infill ☒ other: stabilize base, collect & store fragments; consider using flush
marker to reproduce inscriptions

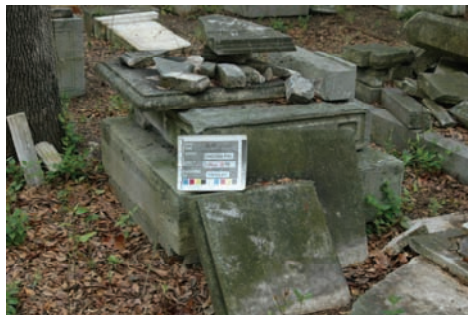
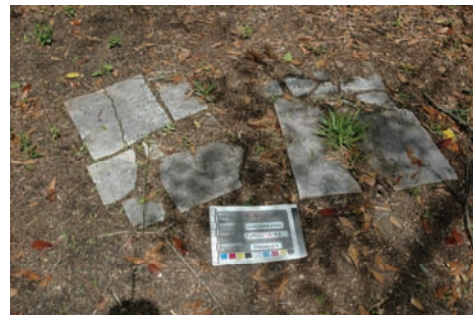
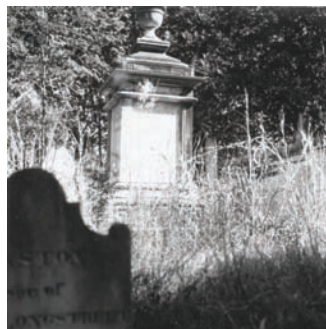
Cottage Cemetery, Augusta, GA Monument Treatment Proposal

Position: ☐ fallen ☐ tilted ☒ unstable ☐ unattached/loose ☐ missing

Deterioration: ☒ broken ☐ cracked ☐ losses ☐ flaking/sugaring ☐ ferrous pins ☐ brass pins
☐ delamination/detachment ☐ spalling ☒ missing fragments ☐ other:

Soiling: ☒ biological ☐ staining ☐ efflorescence ☐ other:

Treatment: ☐ core drill ☐ drill and pin ☐ simple adhesive repair ☐ injection grout ☐ replace bricks
☐ mortar ☐ repoint ☐ infill ☒ other: stabilize foundation, collect and store fragments; consider using
flush marker to reproduce inscription.

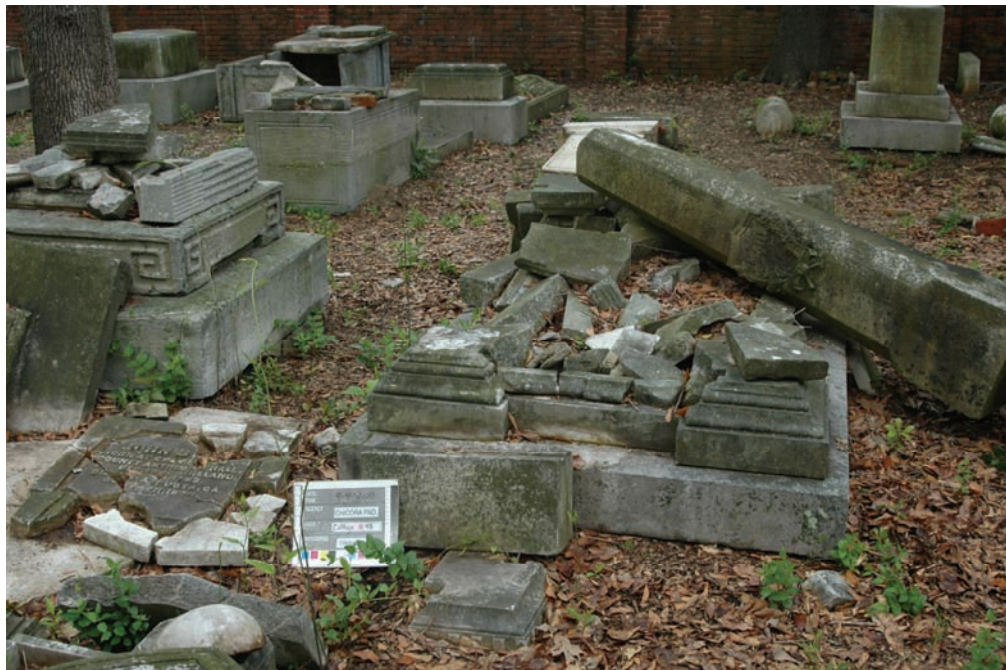
Cottage Cemetery, Augusta, GA Monument Treatment Proposal

Position: ☒ fallen ☐ tilted ☐ unstable ☐ unattached/loose ☐ missing

Deterioration: ☐ broken ☐ cracked ☐ losses ☐ flaking/sugaring ☐ ferrous pins ☐ brass pins
☐ delamination/detachment ☐ spalling ☒ missing fragments ☐ other:

Soiling: ☒ biological ☐ staining ☐ efflorescence ☐ other:

Position: ☐ reset/level in ground ☒ reset/level to existing base ☐ construct new base ☐ resquare
☐ possible new base required ☐ stabilize foundation ☒ reset with 0:1:3 mix ☐ reset with compound

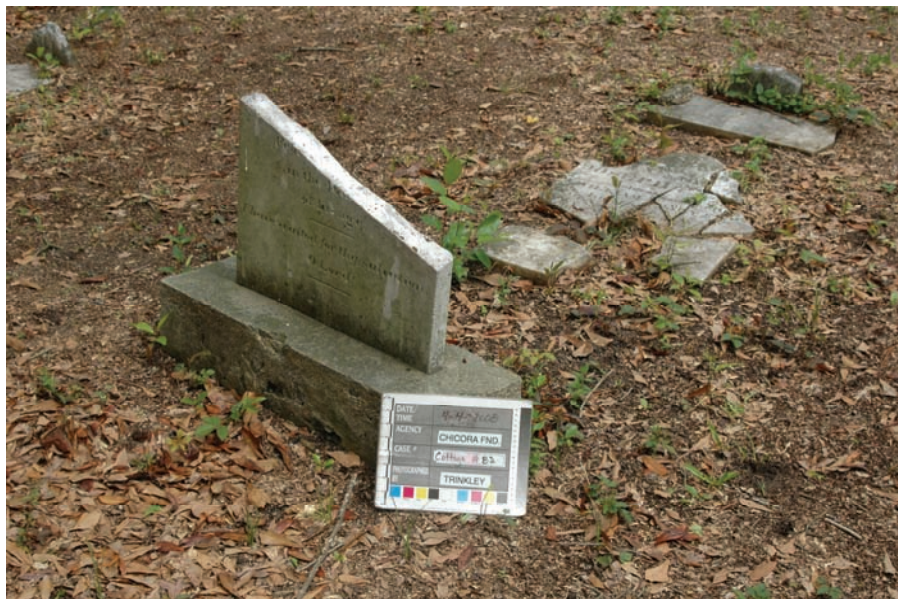
Cottage Cemetery, Augusta, GA Monument Treatment Proposal

Existing Condition

Position: ☒ fallen ☐ tilted ☐ unstable ☐ unattached/loose ☐ missing

Deterioration: ☒ broken ☐ cracked ☐ losses ☐ flaking/sugaring ☐ ferrous pins ☐ brass pins
☐ delamination/detachment ☐ spalling ☒ missing fragments ☐ other:

Failed/Old Treatments: ☐ metal ☒ adhesives/coatings ☐ mortar ☐ other:

Position: ☒ reset/level in ground ☐ reset/level to existing base ☐ construct new base ☐ resquare
☐ possible new base required ☐ stabilize foundation ☐ reset with 0:1:3 mix ☐ reset with compound

Treatment: ☐ core drill ☒ drill and pin ☐ simple adhesive repair ☐ injection grout ☐ replace bricks
☐ mortar ☐ repoint ☒ infill ☒ other: attempt to locate missing portion.

Cost: \$950

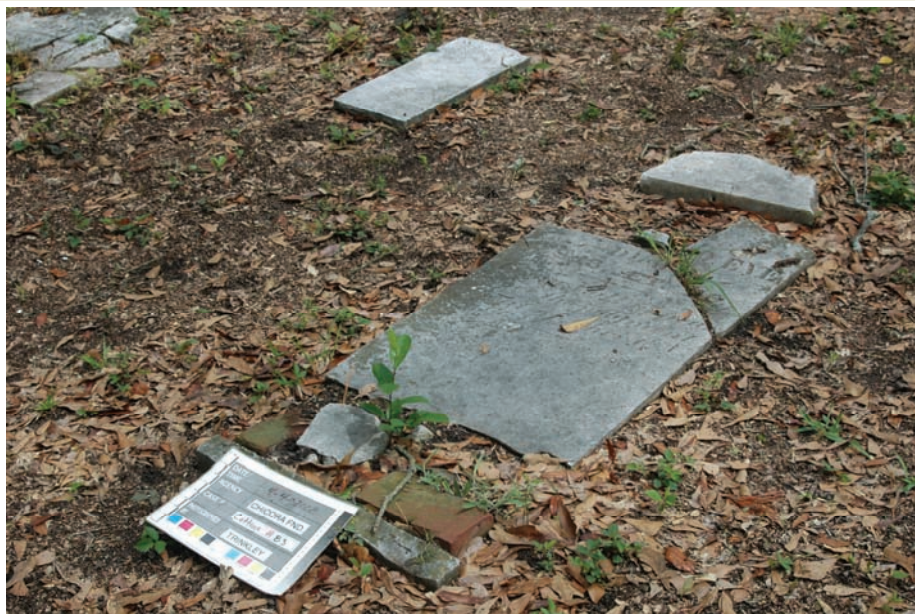
Cottage Cemetery, Augusta, GA Monument Treatment Proposal

Existing Condition

Position: ☒ fallen ☐ tilted ☐ unstable ☐ unattached/loose ☐ missing

Deterioration: ☐ broken ☐ cracked ☐ losses ☐ flaking/sugaring ☒ ferrous pins ☐ brass pins
☐ delamination/detachment ☐ spalling ☐ missing fragments ☐ other:

Soiling: ☒ biological ☐ staining ☐ efflorescence ☐ other:

Position: ☐ reset/level in ground ☒ reset/level to existing base ☐ construct new base ☐ resquare
☐ possible new base required ☐ stabilize foundation ☒ reset with 0:1:3 mix ☐ reset with compound

Treatment: ☒ core drill ☒ drill and pin ☐ simple adhesive repair ☐ injection grout ☐ replace bricks
☐ mortar ☐ repoint ☐ infill ☐ other:

Cost: \$600

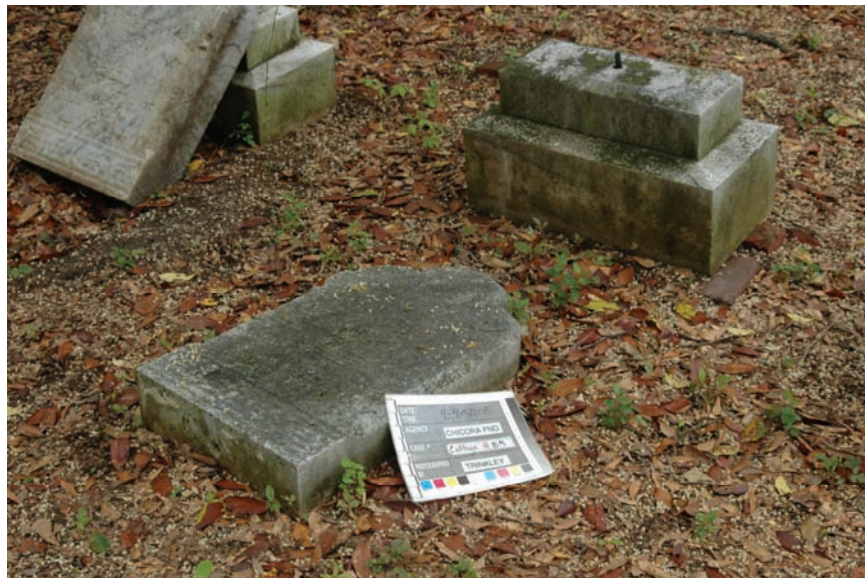
Cottage Cemetery, Augusta, GA Monument Treatment Proposal

Existing Condition

Position: ☒ fallen ☐ tilted ☐ unstable ☐ unattached/loose ☐ missing

Deterioration: ☐ broken ☐ cracked ☐ losses ☐ flaking/sugaring ☒ ferrous pins ☐ brass pins
☐ delamination/detachment ☐ spalling ☐ missing fragments ☐ other:

Soiling: ☒ biological ☐ staining ☐ efflorescence ☐ other:

Position: ☐ reset/level in ground ☒ reset/level to existing base ☐ construct new base ☐ resquare
☐ possible new base required ☐ stabilize foundation ☒ reset with 0:1:3 mix ☐ reset with compound

Treatment: ☒ core drill ☒ drill and pin ☐ simple adhesive repair ☐ injection grout ☐ replace bricks
☐ mortar ☐ repoint ☐ infill ☐ other:

Cost: \$550

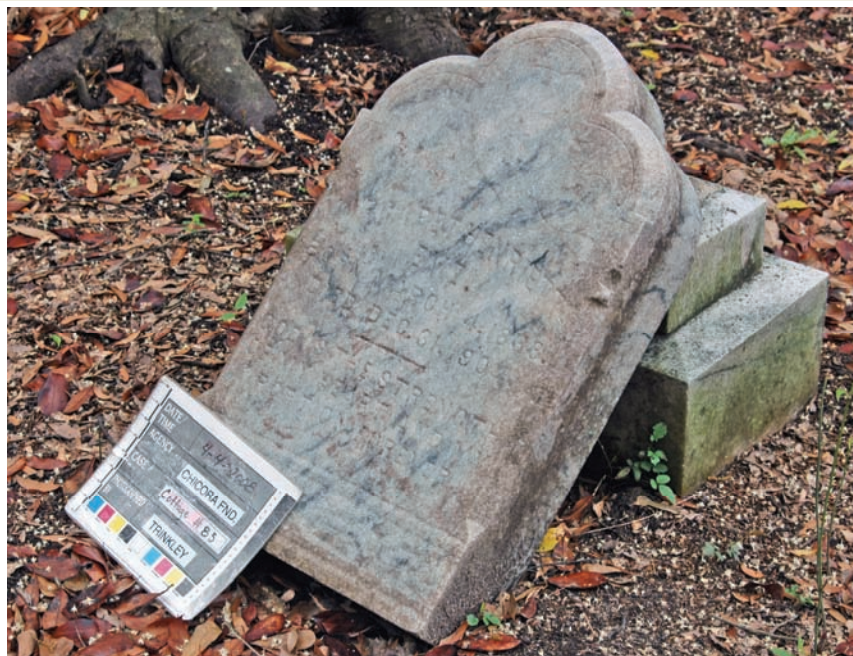
Cottage Cemetery, Augusta, GA Monument Treatment Proposal

Position: ☒ fallen ☐ tilted ☐ unstable ☒ unattached/loose ☐ missing

Existing Condition

Deterioration: ☐ broken ☐ cracked ☐ losses ☐ flaking/sugaring ☒ ferrous pins ☐ brass pins
☐ delamination/detachment ☐ spalling ☐ missing fragments ☐ other:

Soiling: ☒ biological ☐ staining ☐ efflorescence ☐ other:

Position: ☐ reset/level in ground ☒ reset/level to existing base ☐ construct new base ☐ resquare
☐ possible new base required ☐ stabilize foundation ☒ reset with 0:1:3 mix ☐ reset with compound

Treatment: ☐ core drill ☒ drill and pin ☐ simple adhesive repair ☐ injection grout ☐ replace bricks
☐ mortar ☐ repoint ☐ infill ☐ other:

Cost: \$550

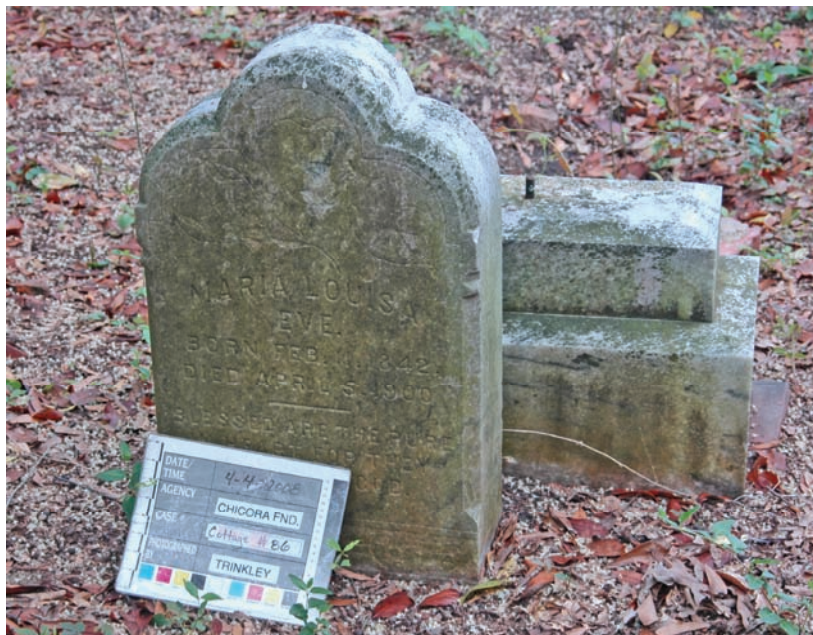
Cottage Cemetery, Augusta, GA Monument Treatment Proposal

Existing Condition

Position: ☒ fallen ☐ tilted ☐ unstable ☐ unattached/loose ☐ missing

Deterioration: ☒ broken ☐ cracked ☐ losses ☐ flaking/sugaring ☐ ferrous pins ☐ brass pins
☐ delamination/detachment ☐ spalling ☐ missing fragments ☐ other:

Soiling: ☒ biological ☐ staining ☐ efflorescence ☐ other:

Cost: **\$1,100**
